REPORT OF INVESTIGATION

**Surface Nonmetal Mine
(Cement)**

**Fatal Fall of Person Accident
October 11, 2008**

**Lone Star Quarry & Mill
Buzzi Unicem USA
Cape Girardeau, Cape Girardeau County, Missouri
Mine ID No. 23-00134**

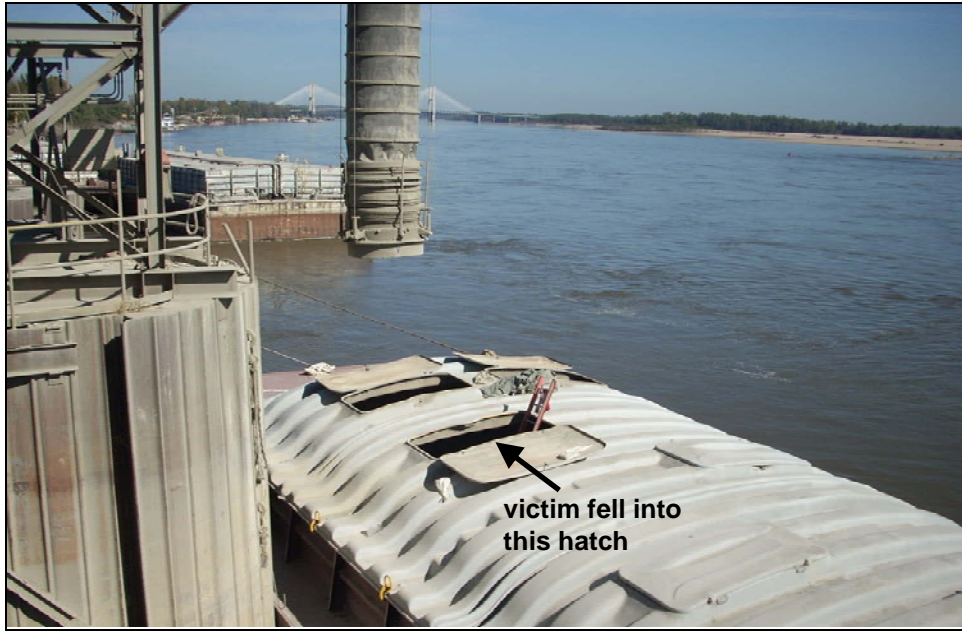
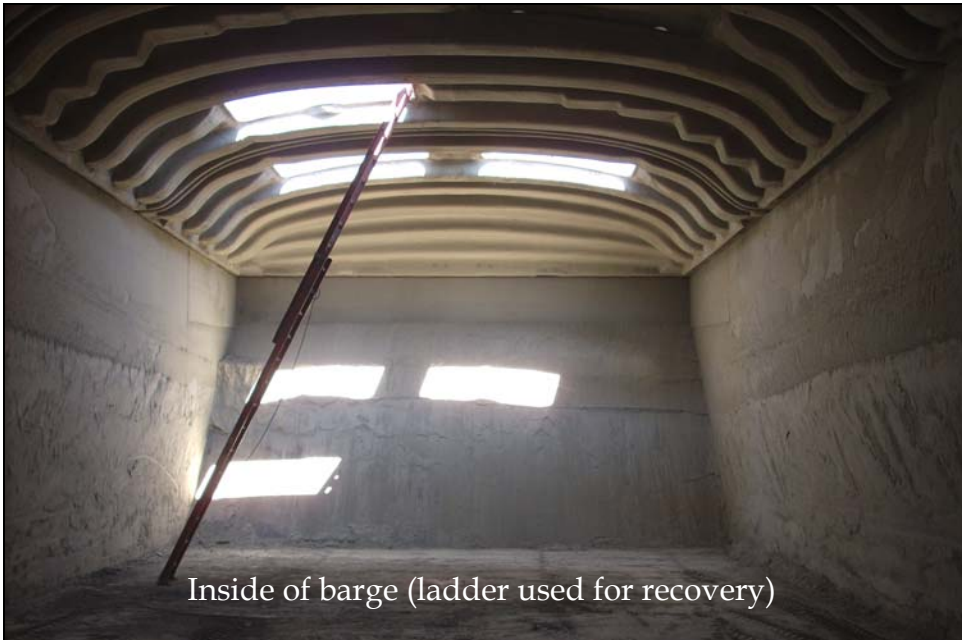
On October 11, 2008, Thomas F. Eftink, cement handler, age 67, was fatally injured when he fell through an open hatch on a barge while attempting to cover a dust collection hatch with a tarp. He landed on the barge floor 20 feet below.

The barge involved in the accident was a “grain” barge. It was 35 feet wide, 200 feet long, and had a fill capacity of 1,800 tons. The top of the barge was equipped with 10 removable concave fiberglass sections that formed a cover over it.

The barge cover had nine hatches on one side and eight hatches on the opposite side. Each hatch opening measured 94 inches side to side, 50 inches front to rear, and was provided with a hatch door. Each hatch door was equipped with a single latch on the 94-inch side toward the rear of the barge and two hinges on the 94-inch side toward the front of the barge.

The hatch doors were opened and closed as the cement fill spout and dust collector tube were moved from hatch to hatch during the loading process. The distance from the hatch doors to the inside bottom of the grain barge was 20 feet.

Corrective Action: Management should conduct a risk assessment to identify all possible hazards to protect persons working on the tops of the barges. A permanent fall protection system should be installed at the barge loading facility to protect persons where there is a danger of falling.
